Butler family of St. Matthews

Chimney steals energy savings

Home Energy Efficiency Makeover

Linda Butler's home, St. Matthews, SC

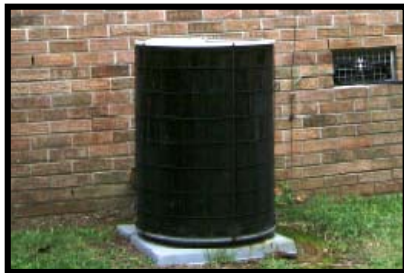
The 10 year-old heat pump was operating 6-8 SEER (Seasonal Energy Efficiency Ratio) -- less than half the efficiency of modern units. It needed to be replaced.

- Comfort Services of Columbia replaced the 1999 2.5 ton heat pump that had a 10 SEER efficiency rating when it was new (the estimated operating efficiency was 6-8 SEER at the time of replacement) with a 2-ton 15 SEER Lennox heat pump. The new system actually has a smaller capacity than the previous one because insulation and duct improvements have reduced how much heating and cooling the home needs.
- The manual thermostat was replaced with a Honeywell 6000 programmable thermostat that is ENERGY STAR qualified.

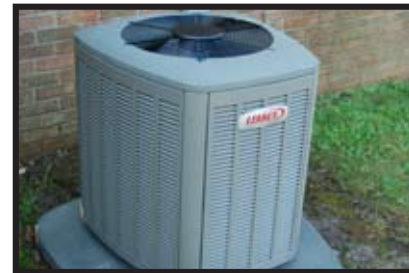
A new high-efficiency Lennox heat pump and programmable thermostat will dramatically improve comfort and energy savings in the home.

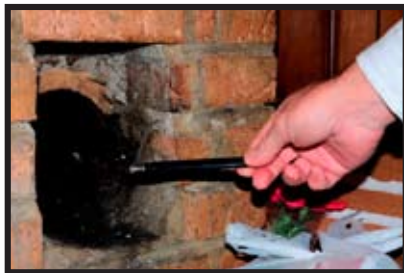
Tests showed the house was five times as drafty as it should be if it were properly air sealed. The main source of the air leaks was a wood stove chimney that was no longer in use. The stove pipe had been plugged with newspaper, but the attic and wall space around the chimney was open.

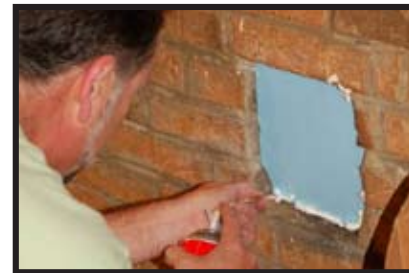
Gaps around the chimney, doors, windows and other areas were caulked and sealed. Blown cellulose insulation was installed in the attic, and a new, insulated attic entry door was created. A vapor barrier and batt insulation were installed in the crawl space.

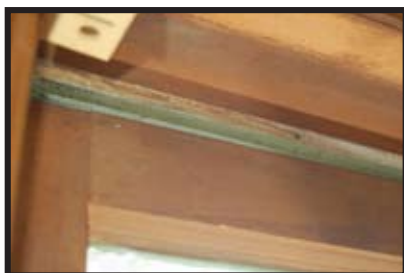
Windows were leaky, warped and missing the hardware needed to close and lock them properly. Exterior doors also were leaky and lacking proper foam or vinyl insulation sealing.

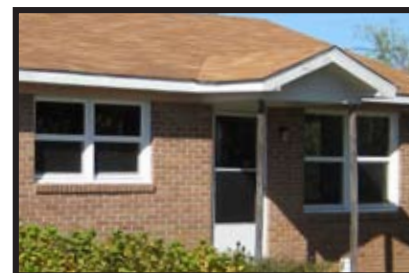
Replacement windows, new caulk and sealing around windows and doors will help protect the home from outside air infiltrating the home, improving comfort and efficiency.
