The Henking and Drummond family of Woodruff

Teacher slays dinosaur propane furnace in home built by her grandfather

Home Energy Efficiency Makeover

Eric Henking, Melissa Drummond & sons, Woodruff, SC

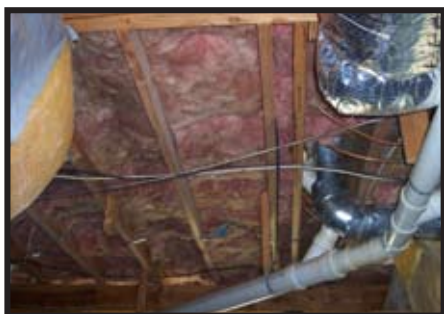
As with many homes, insulation in Eric and Melissa’s attic, basement and crawlspace was inadequate, having settled or deteriorated over time. Those problems compromised the home’s protective barrier against extreme hot and cold outside temperatures.

- In the attic, Glenco Foam replaced the 3.5 inch fiberglass batts on the attic floor, rated at R-13 efficiency, with 5.5 inches of Icynene spray foam insulation under the roof deck equivalent to R-20 and 3.5 inches of foam at the roof gable ends equivalent to R-13. The attic area now meets the building code for today's construction.

- In the basement and crawlspace, the ceiling above these unconditioned areas, where there was no insulation, Glenco Foam sprayed 3.5 inches of icynene foam which also sealed electrical/plumbing penetrations and formed an air barrier for the conditioned living space above.

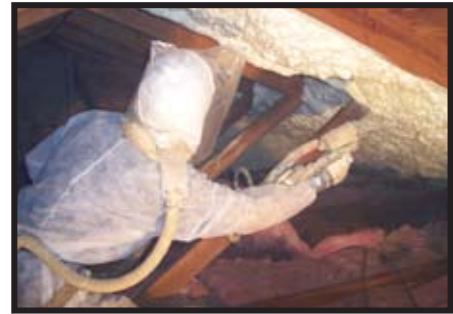
Glenco Foam applied Icynene foam under the attic roof deck and on unconditioned areas in the basement and crawlspace. They also sealed electrical/plumbing penetrations, forming an effective air barrier for the home.
