# Runyon Family in Beech Island

*New furnace had brought same old problems*

**Home Energy Efficiency Makeover**

The Runyon family, Beech Island, SC

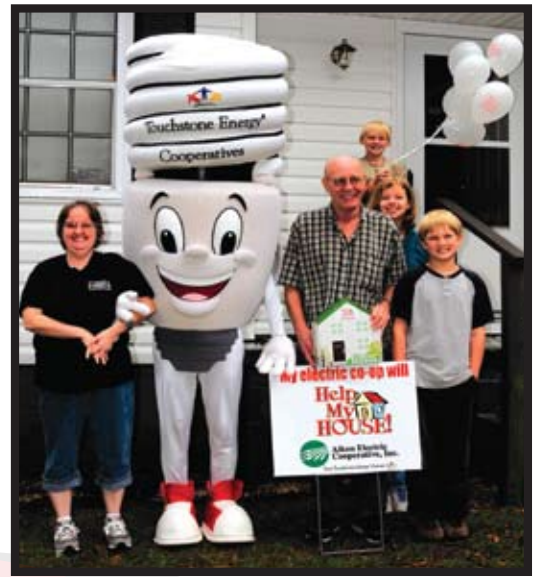
The Runyons had replaced both their electric furnace and air conditioner within the past three years, but their duct system remained very leaky; their attic insulation was inadequate; and their water heater was ready to burst. So, despite their investments in energy efficiency, their electric bills were still higher than average given the size of their home.
